STATE REGIONAL LAUNDRY

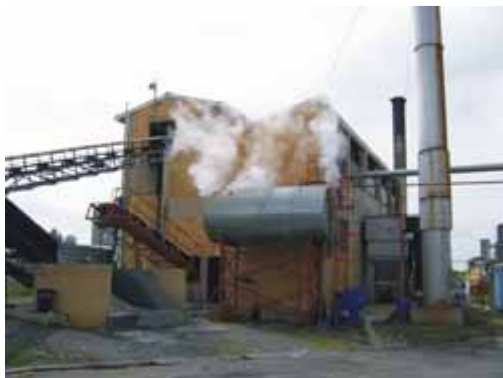
Regional Laundry Kroonstad, located in the Free State province, was experiencing high steam loss, as can be seen by the blowing at the condensate receiver tank. According to operating personnel, this problem had persisted for years, in spite of regular steam trap maintenance.

CONDENSATE RECEIVER TANK BEFORE

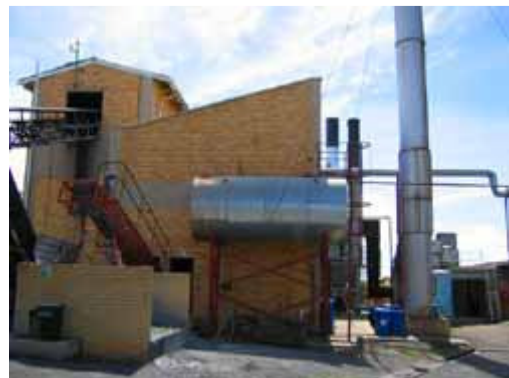
Upon commissioning of the Maxiflo® system, the pressure in return lines was reduced to the extent that the laundry appeared to be offline. (See image below)

AFTER MAXIFLO® CONVERSION

The laundry was thereafter converted to the Proudly South African accredited Maxiflo® ejector system, with staggering results:
